# **HOME INSPECTION REPORT**

SAMPLE

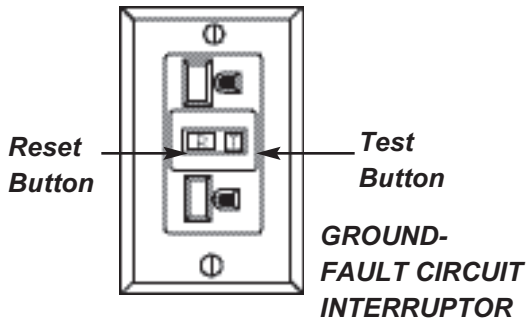
Every effort has been made to evaluate the size of the service. Three wires going into the home indicate 240 volts. The total amperage can be difficult to determine. We highly recommend that ground fault circuit interrupters (GFCI) be connected to all receptacles around water. This device automatically shuts the circuit off when it senses a current leak to ground. This device can be purchased in most hardware stores. GFCI's are recommended by all receptacles located near water, outside receptacles, or garage receptacles. Pool receptacles should also be protected with a GFCI.

See diagram below:

If you do have GFCI's, it is recommended that you test them monthly. When you push the test button, the reset button should pop out, shutting off the circuit. If it doesn't, the breaker is not working properly. If you don't test them once a month, the breakers have a tendency to stick and may not protect you when needed.

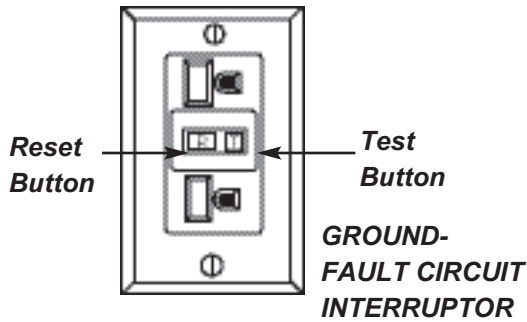
Every effort has been made to evaluate the size of the service. Three wires going into the home indicate 120 volts. The total amperage can be difficult to determine. We highly recommend that ground fault circuit interrupters (GFCI) be connected to all receptacles around water. This device automatically shuts the circuit off when it senses a current leak to ground. This device can be purchased in most hardware stores. GFCI's are recommended by all receptacles located near water, outside receptacles, or garage receptacles. Pool receptacles should be protected with a GFCI. See diagram below:

If you do have GFCI's, it is recommended that you test and reset them monthly. When you push the test button, the reset button should pop out, shutting off the circuit. If it doesn't, the breaker is not working properly. If you don't test them once a month, the breakers have a tendency to stick and may not protect you when needed.
